# AAA Service Advisory

**Vehicle:** 2010-2012 Chevrolet Malibu

**SA-09 5/22/2012**

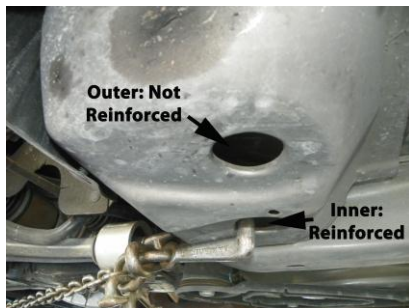
Inner hole can be used for loading if all wheels roll freely

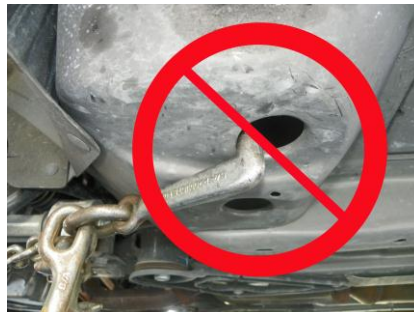
Do not use outer hole for loading

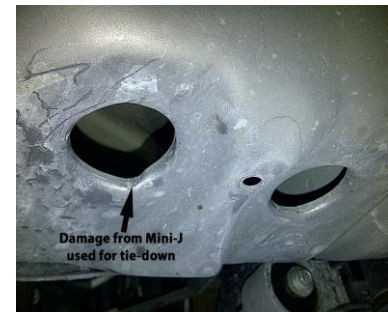
Although this current body style was released in 2008, only the 2010-2012 models **do not** have "T" hole slots in the unibody frame sections. 2010-2012 Chevrolet Malibus have round holes cut into the unibody instead. Although these holes have an inward rolled edge, only the inboard front holes have a reinforced second layer of steel. If the front outboard or rear frame section holes are used during a substantial pull such as performing a recovery or when tightening tie-down devices, these holes can be elongated and damage the unibody structure, resulting in a costly damage repair.

Outer hole damaged during tie down

The preferred method for recovering or loading these vehicles is the use of nylon straps around the lower control arms on the front or through the upper rear suspension mount on the rear of the vehicle. **Once loaded, the vehicle should be secured with nylon wheel straps to prevent damage.**
