The following updates are provided as a courtesy to the towing community.

Saab Oil Pan Damage Caution

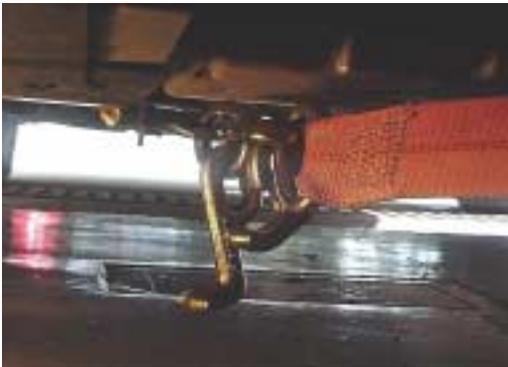
The Problem

The oil pans on newer Saab models can be damaged while the vehicle is being transported on a flatbed type tow truck. This is especially true with 1999-02 Saab 9.3 models and the 2003 Saab 9.3 2-door and convertible models. The damage is apparently being caused by the cluster hook assembly on the end of the winch bridle getting jammed between the oil pan and the surface of the flatbed while the vehicle is being transported. The reason that this is happening is due to the type of attachment that is required to load the newer Saab models onto a flatbed type tow truck and the proximity of the attachment point to the engine oil pan. The pictures below show the proximity of these pieces and the possible result if care is not taken.

Not all cluster assemblies are of the same design. The one pictured here uses 2 rings to support 3 different hooks. Some cluster assemblies will only use 1 ring to support 3 different hooks, which would present an even bigger challenge in transporting the newer Saab vehicles without damage.

Below are four different methods that the tow truck operator can use to eliminate the risk of causing oil pan damage on these vehicles:

- Tow the vehicle on a wheel lift and ensure that the "L" arms or wheel grids are in tight enough to the tires to ensure adequate clearance between the engine oil pan and the cross tube on the wheel lift. This may require jacking the vehicle up to get the "L" arms in tighter.

- When transporting newer Saab models on a flatbed type tow truck, secure the vehicle to the flatbed surface using nylon straps around the wheels and slacken the winch line and bridle assembly during transportation. Do not forget to retighten the bridle before loosening the nylon strap at the unloading destination.

- Place a 2 by 4 or similar block of wood between the cluster assembly and the oil pan when loading. Use a block of wood that is long enough to catch the frame section on the passenger side of the vehicle and extend to the underside of the transaxle. This will help disperse any loads on the oil pan from the cluster assembly during transportation.

- When using the loading eyelets on the underside of the newer Saab vehicle to secure it to a flatbed, use only a single "mini-J" hook on each side connected to a nylon or chain bridle assembly, **DO NOT USE A "MINI-J" THAT IS PART OF A HOOK CLUSTER.**

If your only option is to use a "mini-J" hook that is part of a cluster assembly, use the outboard keyhole slots on the flatbed surface to secure the other end of the strap or chain as this will give an outward pull and avoid having the securing device run underneath the oil pan.

Using a conventional loading bridle, securing the vehicle to the tow truck surface with nylon straps around each wheel and slacken the loading bridle during transport is the preferred method.
