2003-2005 Lincoln Aviator Lockout Guide

FORD 15 AND 21 ALTERNATE PROCEDURE

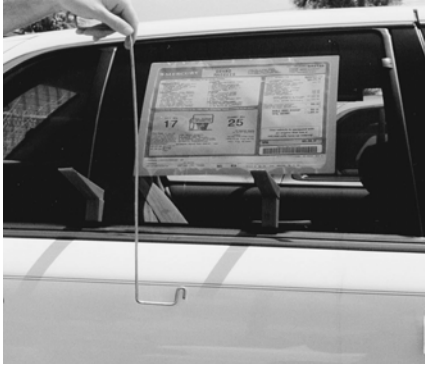
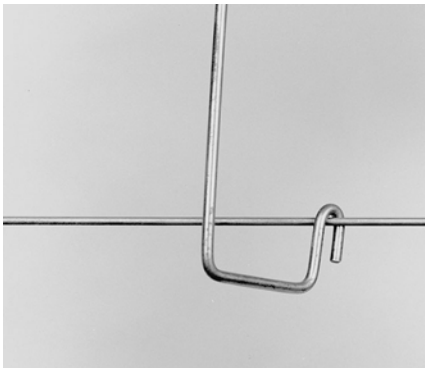
LINKAGE					
Horizontal Rod Forward					
<p>Opening Instructions:</p> <ol style="list-style-type: none"> Using 1 or 2 wedges, carefully open a ¼ inch gap between the glass and sill weatherstrip just forward of the quarter glass post on the right rear door. Use a light probe to identify the linkage and any wiring or components to be avoided. Enter the tool with the tip facing forward and the shaft 2 inches forward of the quarter glass post. Lower the tool through into the door cavity 4 inches then turn the tip of the tool to face straight inward at 12 o'clock. Continue lowering the tool, approximately 8 more inches, until contact is made with the lock rod. Bind the tool on the rod by turning the top of the tool counter clockwise then slide the tool forward to unlock the vehicle. <p>Clean the glass and all surfaces in the entry area before leaving the vehicle.</p> <p>CAUTION: Do not use excessive force. If the rod binds, pivot the tool against your thumb at the sill edge to gain leverage.</p>
